10. Where there is a discrepancy between the ESBS mapped by Narla Environmental 2013 and Abel Ecology the applicant will not be permitted to remove any ESBS without a further approval to Council.

11. Prior to the commencement of any works, the applicant shall update the earthworks Grading Analysis plan (Grading Analysis Plan prepared by Ogilvy Clayton Cocking Mead drawing number 08, dated 9 June 2015) to reflect the approved design and in light of the results of condition 10 above.

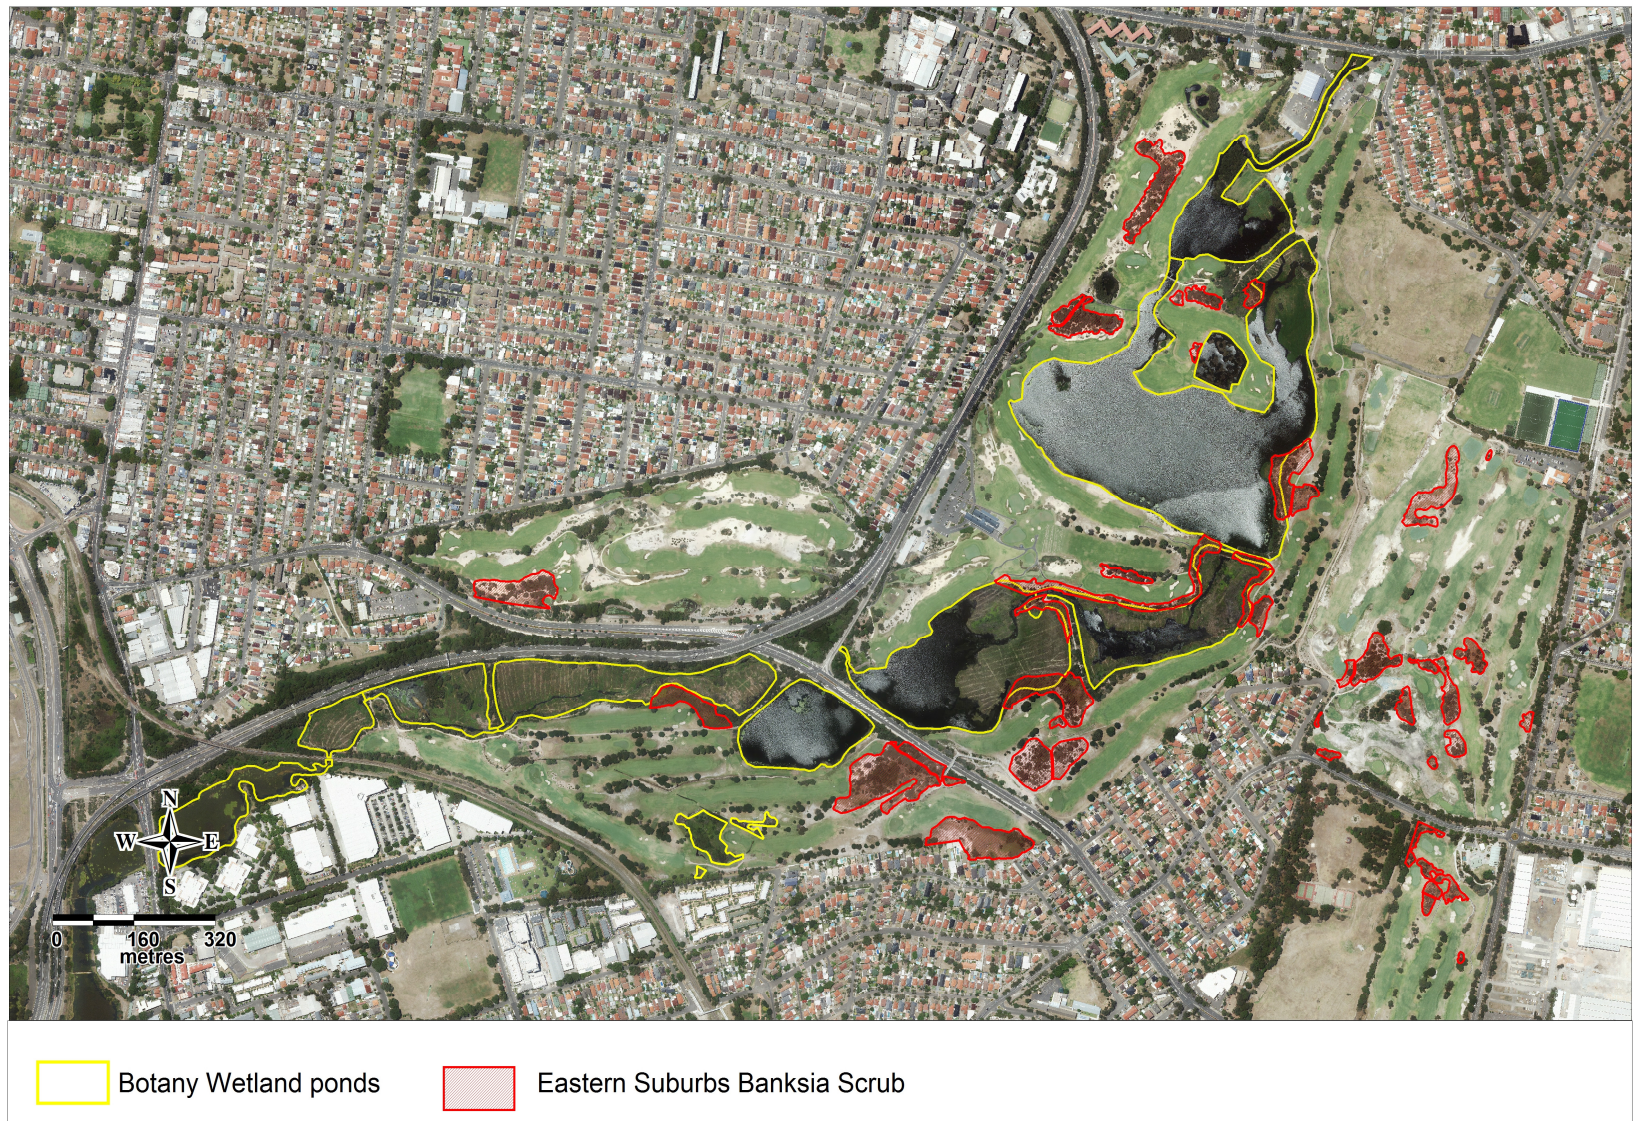
**Figure 2-4.** Eastern Suburbs Banksia Scrub mapping (Narla 2013) overlaid on 2013 aerial image of Botany Wetlands

22. Prior to the commencement of works, detailed earthworks plans showing proposed cut and fill shall be prepared by qualified engineer and submitted to Council for approval. The cut and fill area shall be restricted to the area outside any ESBS Mapped area as indicated on the Narla Environmental Mapping 2013 or as amended by the independent consultant to determine discrepancies between the mapping.

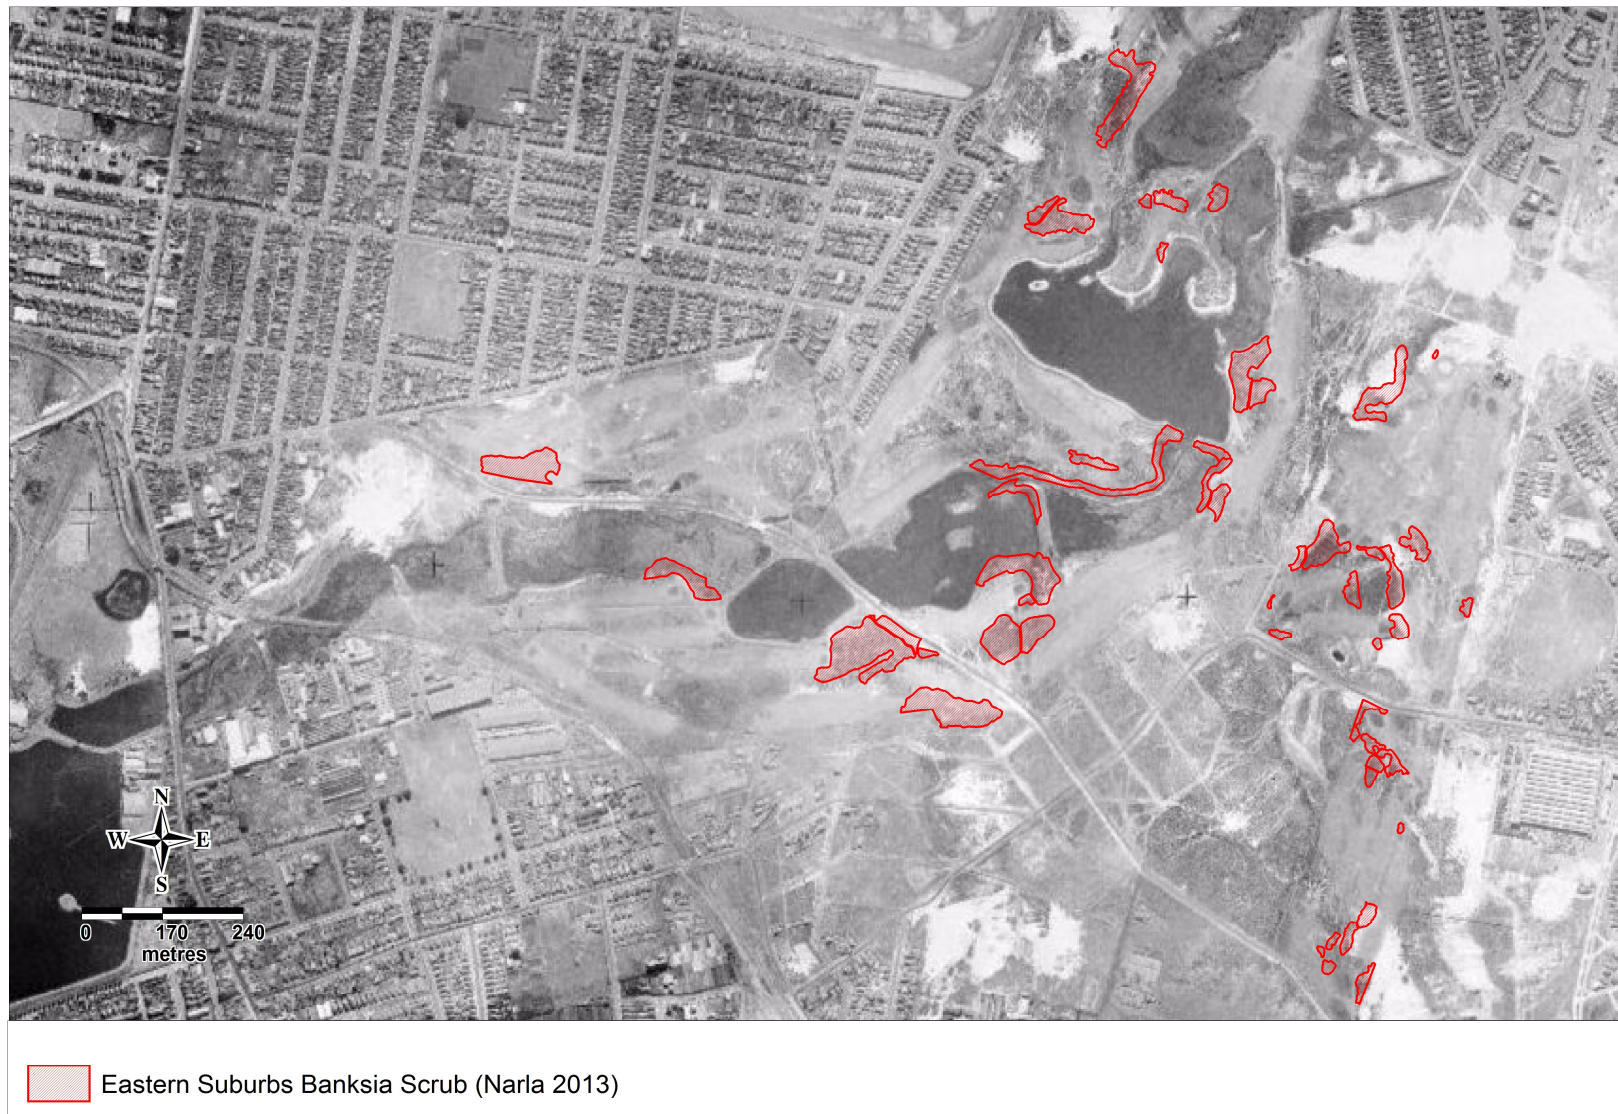
**Figure 2-5.** 2013 ESBS mapping overlaid on 1943 Six Map aerial photo of Botany Wetlands

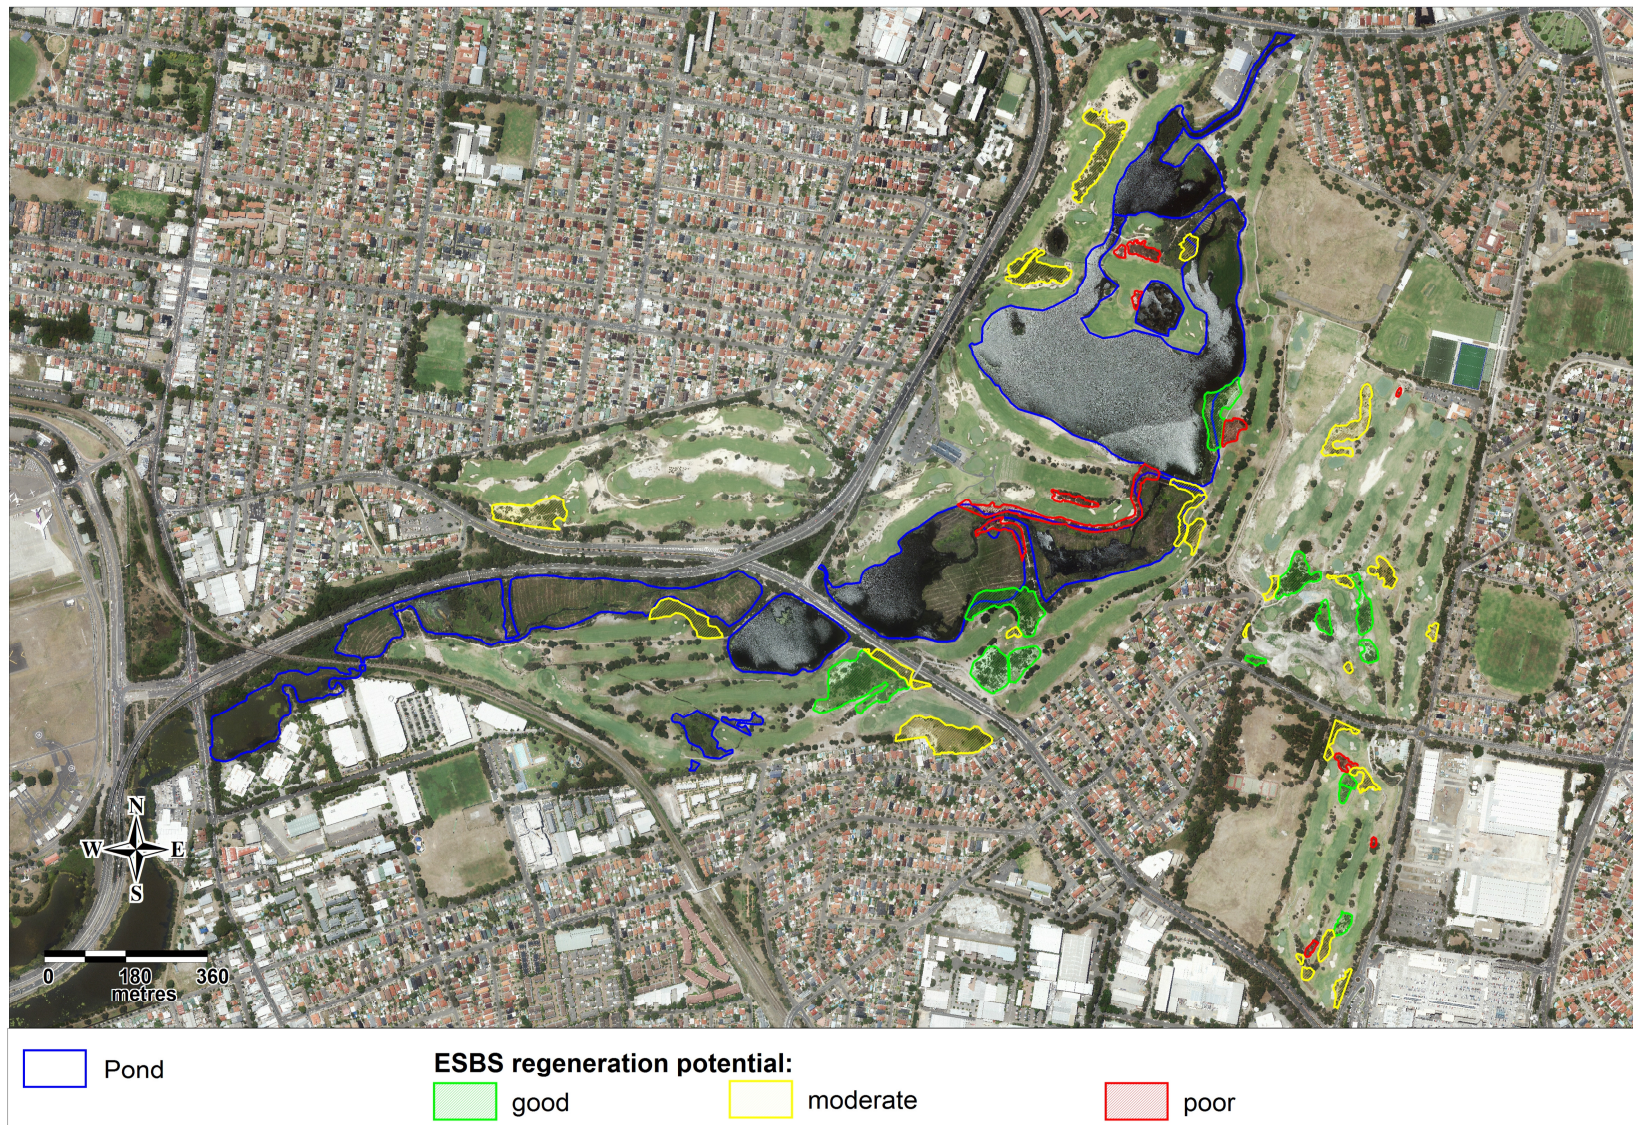
**Figure 2-6.** Eastern Suburbs Banksia Scrub condition mapping
